MODNR ARCHER Hyperspectral Imagery for Contamination Related Analysis

May 2009

Overview

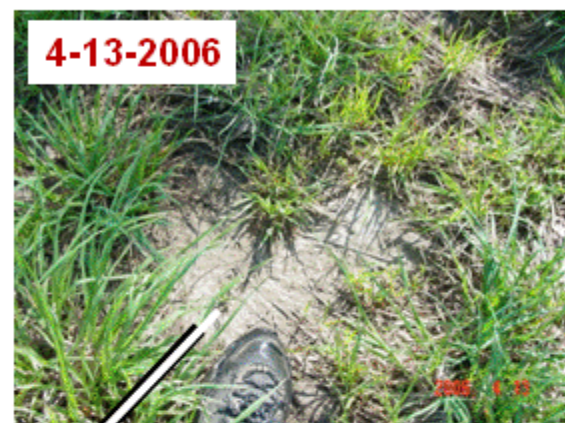
Landfill Seeps & Drainage

- Leachate pond used for spectral signature of contaminants draining from the landfill.
- HSI analysis identified:
 - Previously covered surface seep that has reappeared.
 - Previously detected and new seeps in the creep.
 - Newly discovered dumpsite across from the landfill.

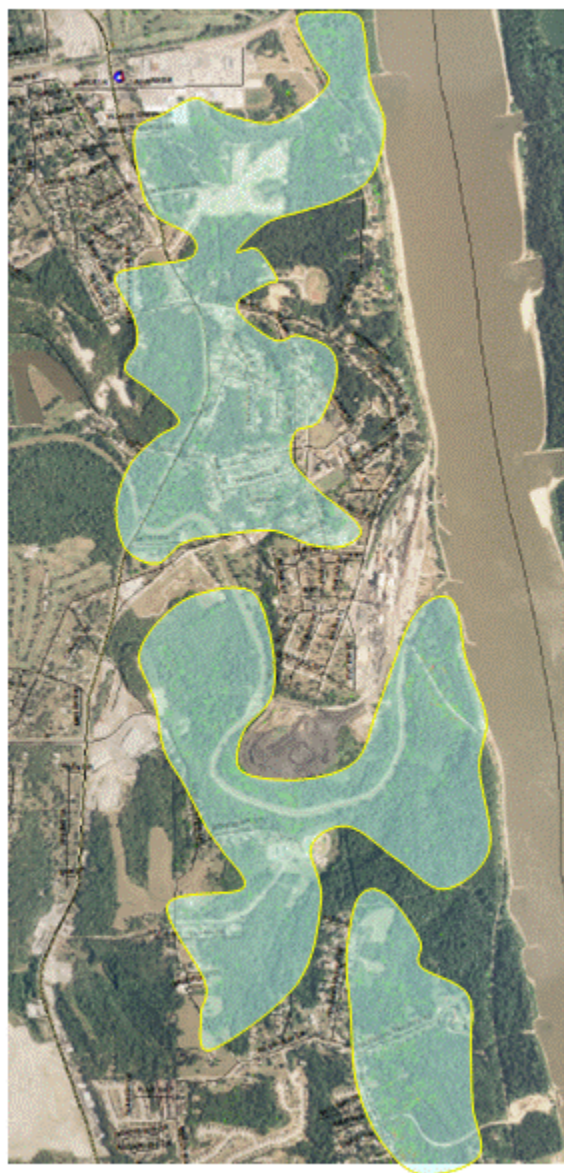
SAM Analysis Deciduous & Conifer South

HTD1 – Deciduous

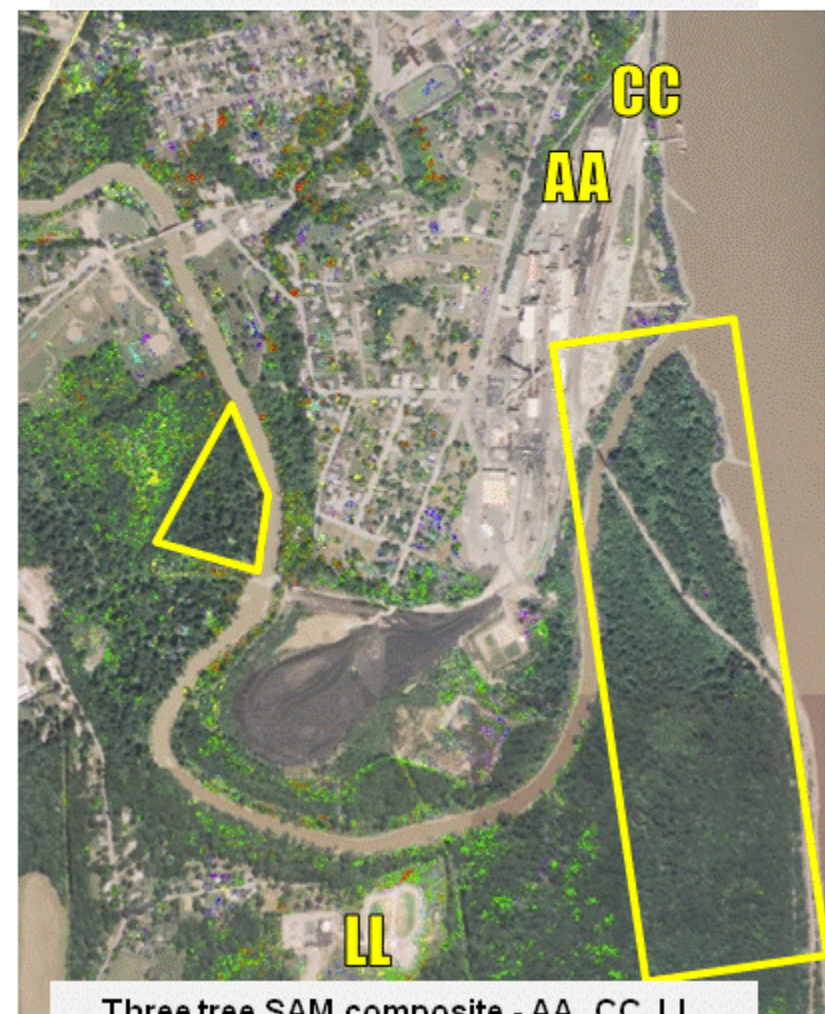
Second SAM Analysis – Conifer

(Trees selected from Field Survey)

AA – Cedar, CC – Pine, LL - Cedar

Three tree SAM composite - AA, CC, LL.

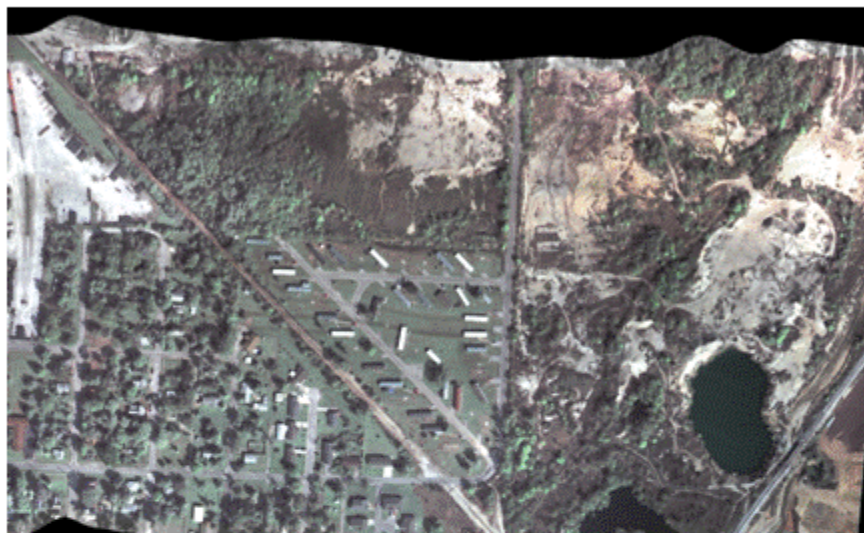
Webb City Endmember

Several signatures for Mine Waste
– orange, dark purple, blue,
maroon, green & yellow.

Pick four signatures
from areas of highest
know lead levels.

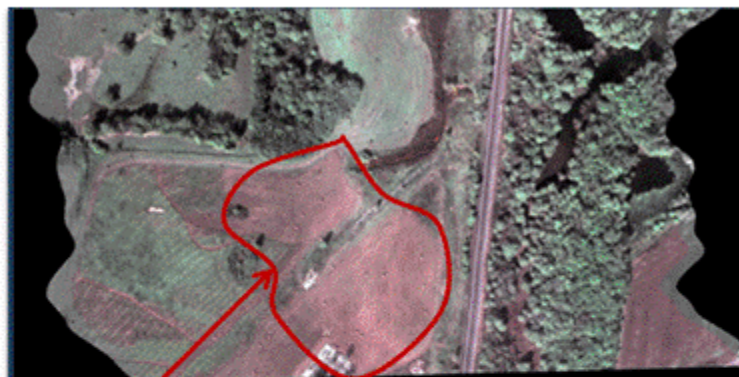
These look like new fields. They don't appear plowed in the 2006 NAIP imagery. Could the farmer be using the spring for irrigation?
